Improved Anti-Personnel Mine Neutralization Device Test Report

Christopher Wanner
U.S. HD R&D

IMPROVED ANTI PERSONNEL MINE NEUTRALIZATION DEVICE TEST REPORT CHRISTOPHER WANNER FEBRUARY 2000

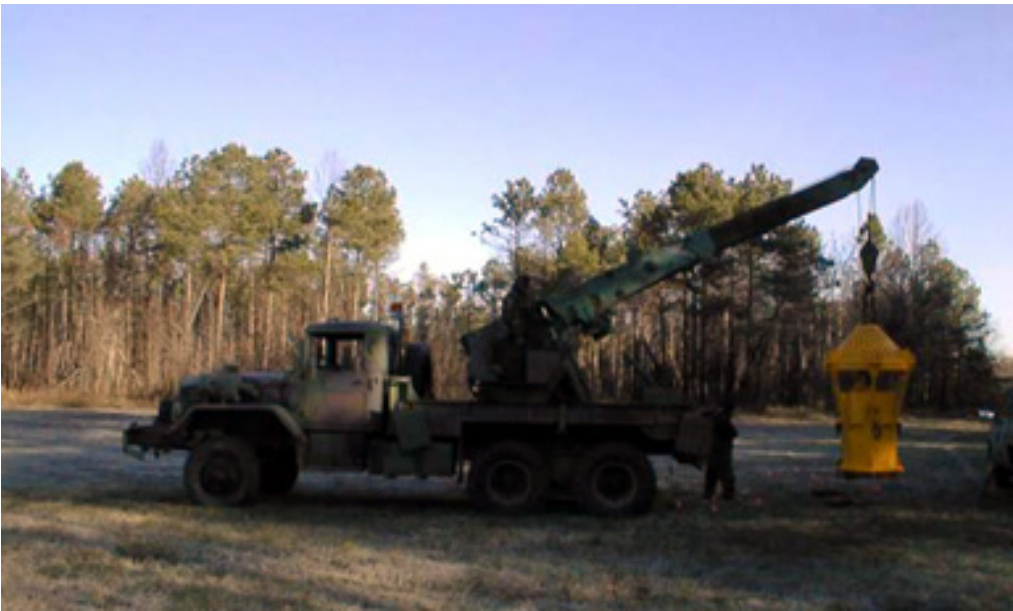
The APMINUD is a mechanical tool designed to safely detonate antipersonnel landmines as part of a peace time clearance operation. The APMINUD consists of a mobile blast and fragment containment shell, with a mechanical striker inside. It can be used in conjunction with a shielded, all terrain vehicle with crane. The vehicle is used to move and lower the shell over a marked mine location. The internal

striker is released and impacts the mine or ground above the mine and actuates the pressure fuze. The blast and fragments from the detonating mine are contained within, or are directed out the top of the shell and away from surrounding personnel and equipment.

FIGURE 1. Improved APMINUD with Placement Wrecker

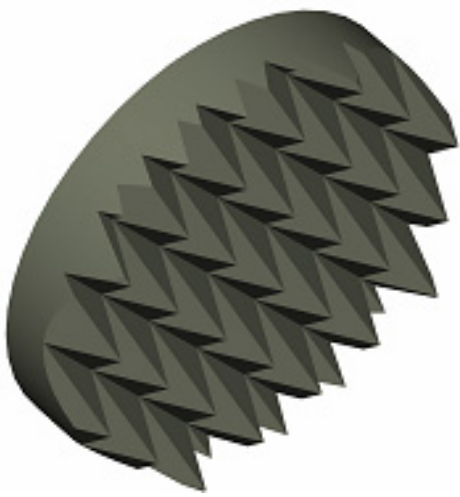
The expendable face, or "standoff", on the hammerhead has also been redesigned. Dead spots in the effectiveness of the strike provided by the hammerhead were discovered in tests with the original APMINUD. The annular ridge pattern on the face of the standoff was causing the detonation success rate to drop significantly at certain combinations of burial depth and offset from the center of the plunger. The standoff units designed for the Improved APMINUD feature a pattern of pyramid shaped spikes protruding from the face at two inch spacing. This design is intended to give the impact footprint more uniform load while still providing the increased soil penetration that results from having protrusions on the standoff face. Israel Aircraft Industries addressed the problem of metallic pieces from the shattered standoffs cluttering the minefield by constructing the standoff elements out of cast rubber instead of aluminum used previously.

FIGURE 3. Rubber Standoff Design for the Improved APMINUD

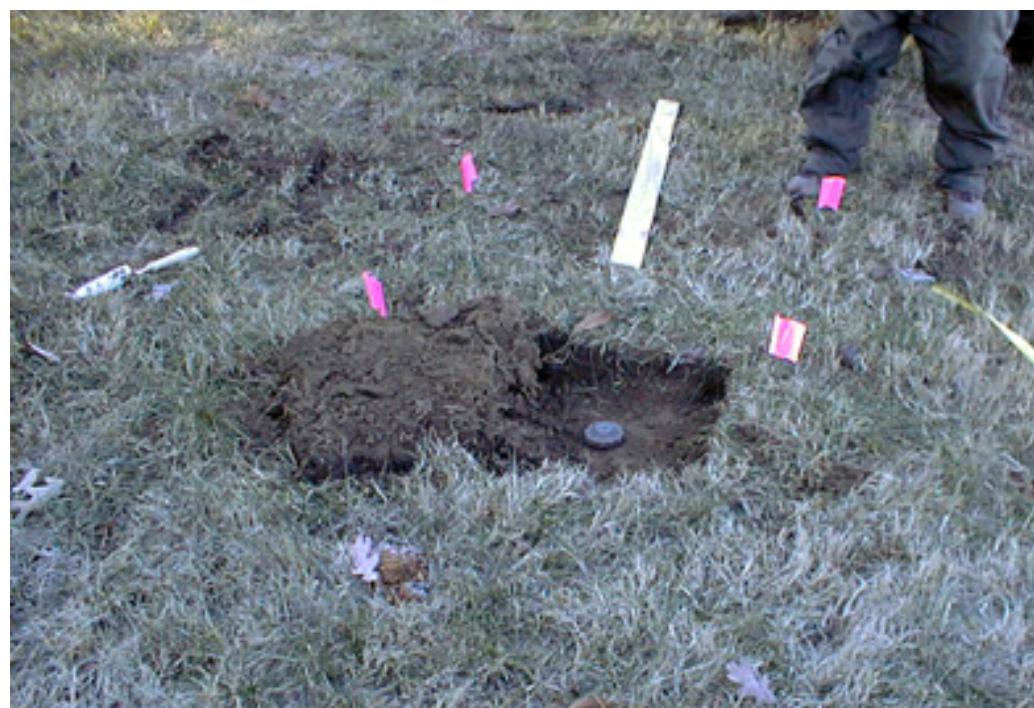
4.2.1 Effect of Vegetation Cover FIGURE 5. MKII Mine Burial in Sod

A series of tests was conducted with mines buried 4" in sod covered clay. These results were compared with results from the mines buried under similar conditions minus the vegetation from the core test program. A truly representative testing of the effect of overgrowth on the results would require burying the mines for a long period of time and allowing vegetation to develop, then performing the test. Since we were not able to create such a condition for this test, the best approximations to this were created in two ways. In most of the tests a square of sod larger than the APMINUD footprint was removed, the mine was buried in the hole left by the sod, and the sod was then replaced, and the test conducted. In some of the tests the burial hole was "drilled" into the sod exactly the size of the mine diameter. The standoff which is much larger than the hole would have to compress the sod all around the hole before impacting the ground above the mine. The method of burial didn't make much difference in the results. The vegetation produced a small reduction in the effectiveness. In these tests, all conducted at 4" burial, 89% of the mines were detonated. This compares to 94% success in the core tests with the same burial conditions except for the

sod cover.
